Sample 2

Laboratory Notes

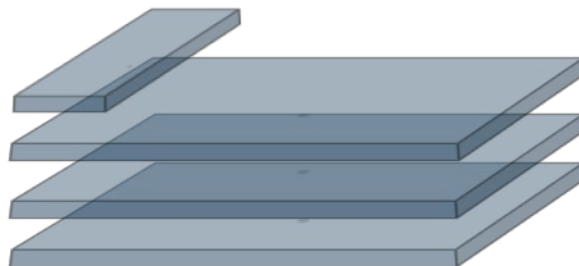
Ply Configuration Reference

Sample Size (As Received)	<u>12 x 12</u>	Material Type	<u>Coal Tar on Fiberglass</u>	Sample Type	<u>Coal Tar Built-Up Roof, Gravel Ballasted</u>
Sample Weight (As Received)	<u>N/A</u>	Insulation Type	<u>None</u>	Bitumen Type	<u>Coal Tar</u>
Water Column		Delamination		Desaturation	
Test Performed:	No	Test Performed	Yes	Test Performed	Yes
Pass/Fail	N/A	Install Ply Count	3		
Time of Fail	N/A	Total # of Plies	5

- Sample 2 appears to be taken from the same roof.
- The sample did not appear to be damaged on top or under side.
- This sample did not have any areas of interest after delamination.
- **Desaturation also did not reveal any damaged areas.**
